Research Article

Fracture Resistance in Fiber Reinforced Composite Restorations – An In Vitro Study

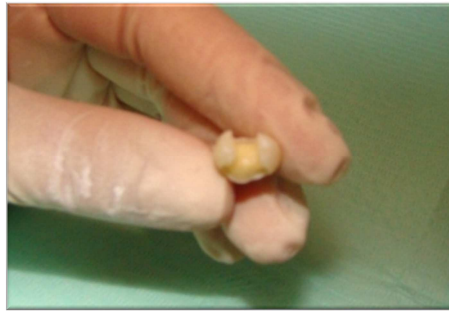
Teeth were divided into three equal groups who underwent the following treatments: the first batch (A) were fully preserved, the second group (B) were drilled resulting in large cavities which have been filled with dimetacrylic resin composite. In the third group (C) large fillings have been reinforced by applying a layer of glass fiber mesh disposed on the pulp wall of the cavity. For groups B and C, large cavities were drilled with respect to the pulp chamber, which included the palatal cusp in premolars, the disto-oral in molars with four cusps, respectively one vestibular cusp in three cusp molars. A simulated cusp fracture complication was added to the MOD cavity. VO size of the cavities was a third of the intercusp distance, measured with the callipers (fig. 1).

Fig. 1: Preparation for a 3 Cusp Molar

Cervical wall was placed at 1 mm from the cement-enamel junction and measured 1 mm in depth. The depth of the cavities was established according to the average tooth substance above the pulp chamber ceiling [1, 2], keeping a 1.5 mm layer of dentin to it.

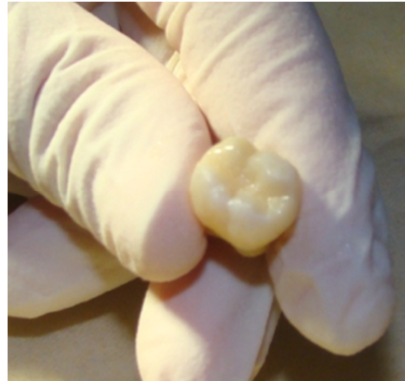
were simultaneously light-cured. Next, we applied composite filling in 2mm layers until the correct morphology of the tooth was achieved (Fig. 3).

Fig. 3: The Final Restoration in a Molar

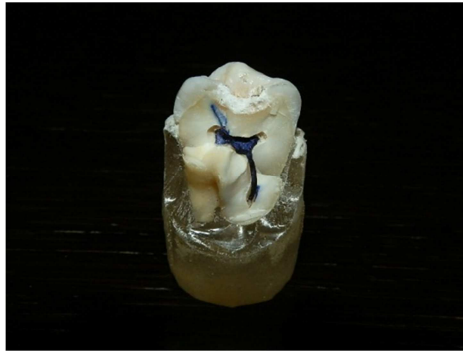
Fig. 7: Cracked Sound Tooth

The analysis consisted of macroscopic assessment of trajectory lines of fracture (Fig.7). Conventionally, a glossy and heterogeneous fracture surface similar to primed and bonded dental tissues was considered an adhesive fracture. Similarly, a heterogeneous fracture surface, but of matte finish, coupled with a matching surface on a detached fragment was interpreted as an invasive tooth fracture. A

smooth homogenous fracture surface A 3,5 shaded was interpreted as being the result of cohesive fracture in the filling.

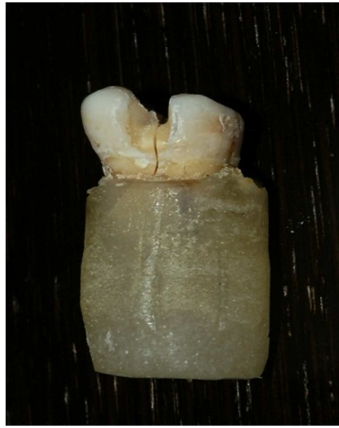
- Molars generally showed fracture lines continued in the dental tissues (Fig. 9)

causing outstanding cusp fractures (three cases), fractures below the cement-enamel junction (two cases) or fractures opening the pulp chamber (one case).

Fig. 9: Fracture Line Continued in the Dental Tissues

In 3 of the 5 molars classically restored with composite resins, the fracture of the filling spread in the remaining natural tissues (cusps, tissues beyond the CEJ), while in molars with reinforced restorations, the remaining tooth structure suffered no damage. The association of fiber reinforcement and lack of tooth structure injury proved to some extent to be significant statistically ($p=0,083$ Fisher test).

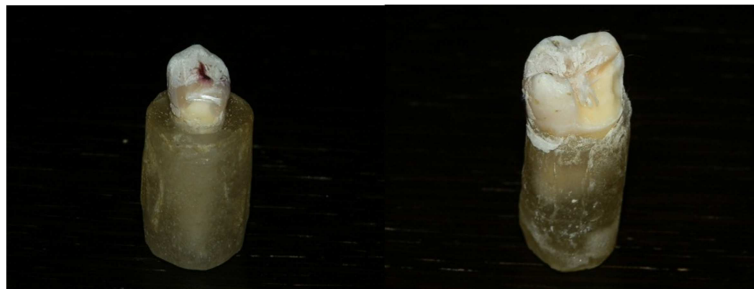
- Most fractures (14 walls out of 22) were due to the adhesive failure of the restorations, and in no circumstance did the fracture line interested remaining dental hard tissues (Fig. 10).

Fig. 10: Failure of Reinforced Fillings

Generally, the adhesive fractures occurred in the pulp wall underneath the fiber mesh. So, there was no disjunction between the glass fibers and the fluid resin applied above it. This result is suggestive of the reliability of the connection between silanised glass fibers and composite resins. However, the fracture line separated fragments of glass fiber mesh, but this is probably due to the fact that the fibers were woven in a loose manner.
