Case Report

Type A Chronic Aortic Dissection in 40-Years Old Smeloff-Cutter Aortic Valve

We report the case of a 60-year-old man undergone an aortic valve replacement with a Smeloff-Cutter prosthesis 40 years ago. The patient underwent a redo aortic valve and ascending aorta replacement for ascending aorta aneurysm that intraoperatively appeared as a chronic Type A aortic dissection. The Smeloff-Cutter prosthesis looked intact and functionally normal. The ascending portion of the aorta appeared dissected two centimeters above the sino-tubular junction, between the non-coronary and the left coronary valsalva sinuses: we speculate that Smeloff-Cutter prosthesis may contribute, due to its rheology and features, to the determinism of aortic dilatation and subsequently dissection.

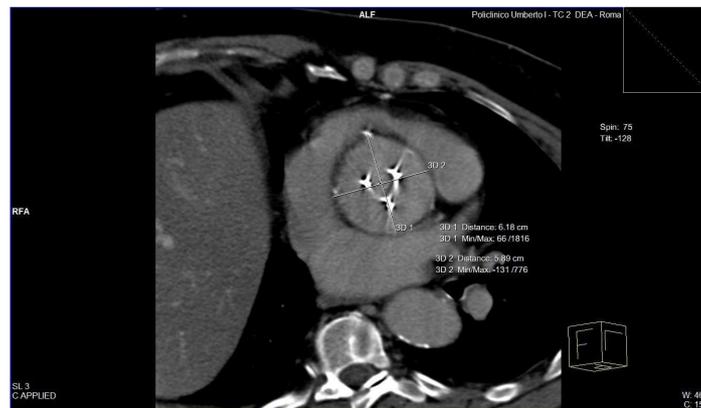
Figure 1A: Contrast-Enhanced Computed Tomographic Scan: Short Axial Image Showing the SC Prosthesis and the Aortic Dilatation

recent onset of chest pain, fatigue and shortness of breath. A transthoracic echocardiogram showed normally functioning SC valve with a peak and mean pressure gradient of 19 and 9 mmHg, respectively, and a dilatation of the aortic root and the ascending aorta. The CT scan confirmed the ascending aorta dilatation with a diameter of 58 mm at the level of the aortic bulb, and 71mm at the level of the sino-tubular junction, with images suspicious for aortic dissection (Fig. 1A, B).

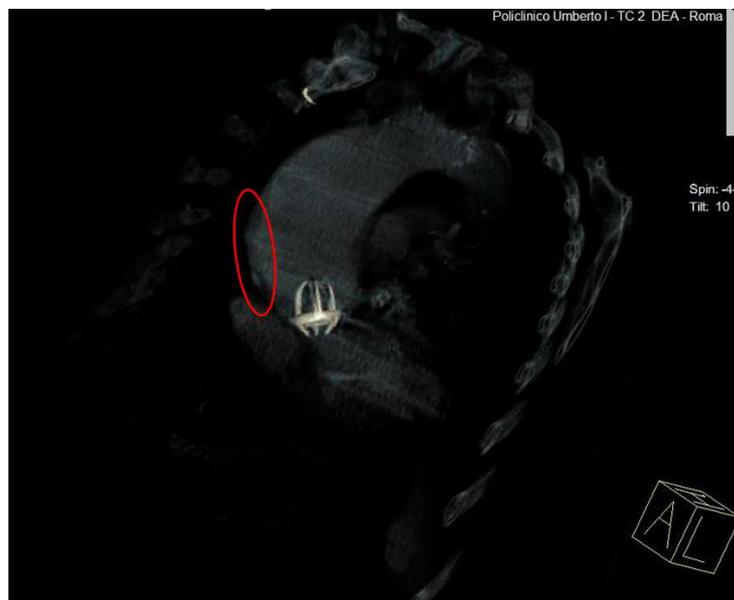
Figure 1B: 3D Reconstruction Showing the SC Prosthesis and the Aortic Dilatation with Suspicious for Aortic Dissection

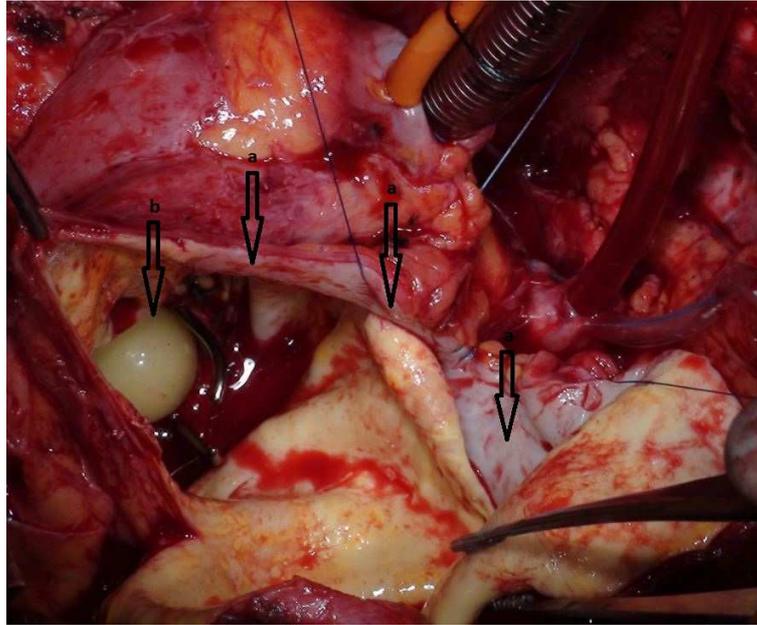
Figure 2: Intraoperative Aspect of the Chronic Aortic Dissection (a) and its Relationship with the SC Valve (b)

of the right axillary artery. Once established cardiopulmonary bypass, the ascending aorta was cross-clamped and opened with evidence of an aortic dissection with a completely thrombosed false lumen and an intimal entry site two centimeters above the sino-tubular junction, between the non-coronary and the left coronary valsalva sinuses (Fig. 2).

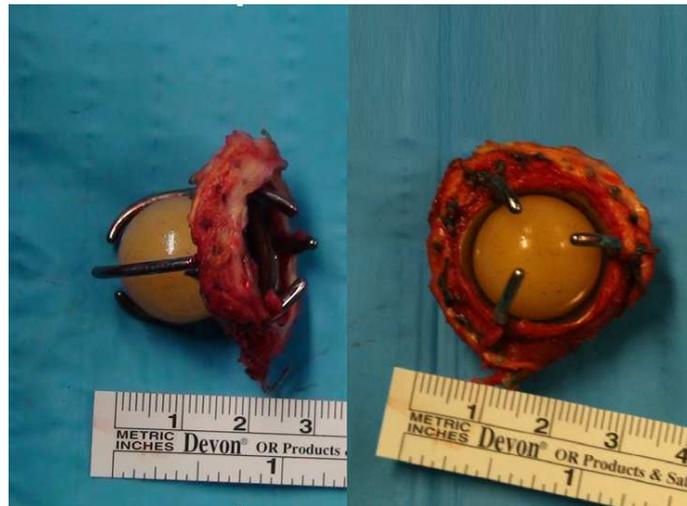
Figure 3: The Explanted SC Valve

Despite the evidence of a well-preserved and functionally normal prosthesis, considering the anatomical findings and the age of the implant, we decided to replace both, valve and ascending aorta using a n° 27 St. Jude valved conduit. The left anterior descending coronary artery was bypassed with the left internal thoracic artery. The patient was subsequently successfully weaned off from extracorporeal circulation. The explanted prosthesis was evaluated on the bench with no evidence of poppet surface's abnormalities, ball lipid absorption or pannus deposition around the struts (Fig. 3). A specimen of the aortic wall (Fig. 4)

In our case the valve didn't show structural abnormalities such as ball variance and the poppet appeared smooth with neither alteration of the circular shape nor macroscopic evident lipid absorption. Surprisingly, even if pannus formation around the struts has been reported as a routine complication⁷, we did not detect either pannus or thrombotic apposition around the valve struts possibly because of the self-washing effect, and the distance of the valve struts from the aortic walls. Blood flow dynamics in ball caged valves might have a significant influence on blood rheology and a great impact in aortic wall degeneration. Thus, it is possible to speculate that flow dynamics imposed by the configuration of the prosthesis causes lateralization of forward flow resulting in blood turbulence and cavitation thus increasing the risk of hemolysis and thromboembolic complications. In our patient moreover, we hypothesized that these lateralized flow characteristics may have contributed to a prolonged increased wall stress, playing a role in the determinism of a progressive aortic dilatation.⁸ To our knowledge, this case represents the longest reported follow up of functionally normal explanted SC aortic valve, confirming the good features of its ultra-structural conformation, but highlighting that its hemodynamic characteristics were possibly cause of the aortic pathology.

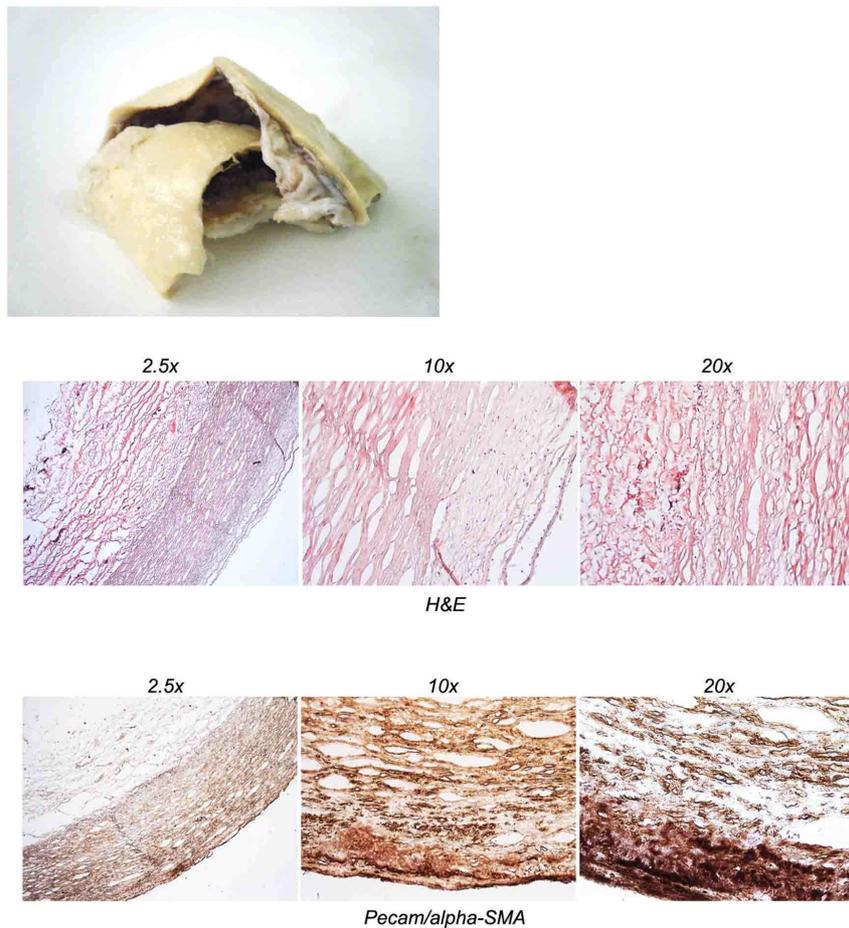
Figure 4: Representative Images of Aortic Wall. (A) Photograph of Full Aortic Biopsy Showing Anatomical Appearance Consistent with Aortic Dissection. (B) Representative Images of H&E Staining of Aortic Wall. (C) Double Immunostaining of Pecam-1/ α -SMA in Sections of Both Lumina at Different Magnifications (2.5x, 100x, 200x).

was sent for histological characterization. Hematoxylin and eosin staining showed similar morphological characteristics of all the three layers of the aortic walls in both primitive and false lumen (Fig. 4). Negative staining for CD34 and Ki67 markers indicated the absence of cell proliferation, suggestive of a stable structure of the aortic wall, as previously described by our group⁴, while double staining of endothelium (Pecam-1), and VSMCs (α -SMA) indicated a completed endothelium regeneration in the false lumen confirming that the dissection had overcome its acute phase.
